Energy Saving Case Study

Muaiwalu House, Suva, Fiji

Fiji Ports Corporation

Bruce Rowse, 8020Green Pty Ltd.

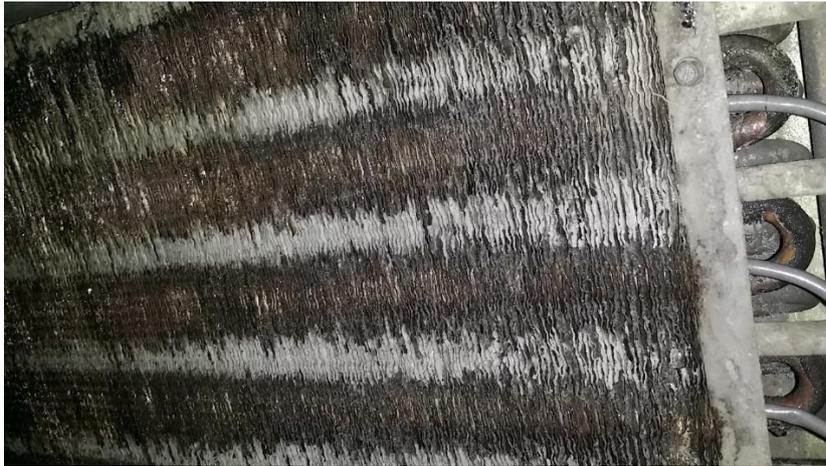
Figure 2 Part of the old air conditioning system.

In the meantime, the centralized air conditioning in Muaiwalu House had becoming increasingly unreliable.

The audit had recommended that split system air conditioning units with greater than standard energy efficiency be installed, and that the existing air conditioning system be totally decommissioned.

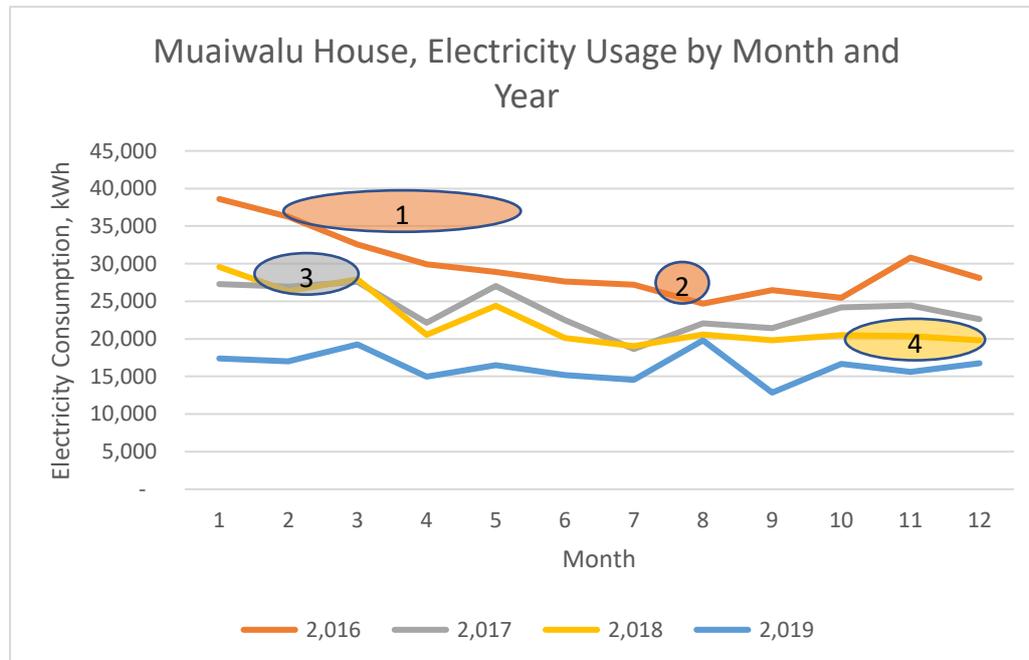
Figure 3 Monthly electricity usage 2016 to 2019

1. Partial air conditioning upgrade
2. Energy audit
3. Lighting upgrade
4. Air conditioning upgrade completed

Comparing 2019 with 2016, electricity consumption was 160,012 kWh (45%) lower, and energy costs were \$62,917 lower, noting that electricity tariffs were largely unchanged.
